Manhole Inspection Summary

Manhole # S05GG2004MH

Insp Date: **7/6/06 10:13 AM**

Location Address: **2506 SHELLEYDALE DR**

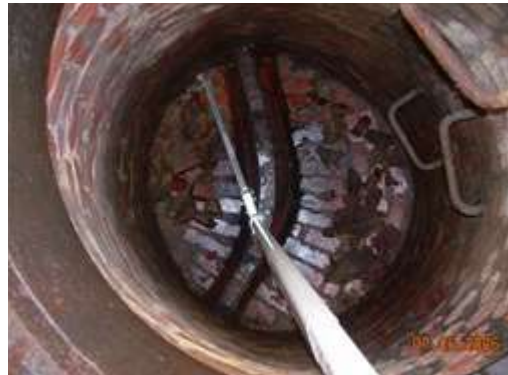
Top View

Frame leaks. Adjustment and Corbel infiltration. Evidence of surcharge - Bench debris. Corroded steps.

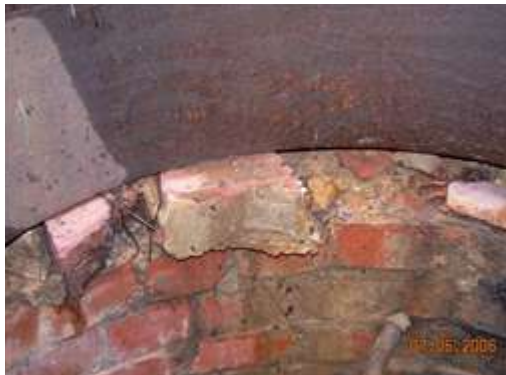
Defect

Frame leaks. Adjustment deterioration, loose brick, root intrusion and infiltration.

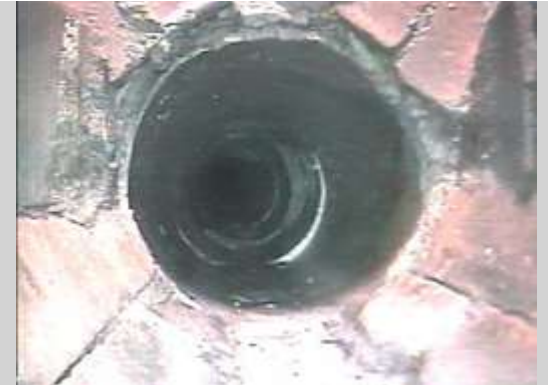
8 in. Circular Gravity Sewer Pipe Out @ 12 O'Clock

Infiltration: **Evidence** Pipe Seal Cond: **Broken**

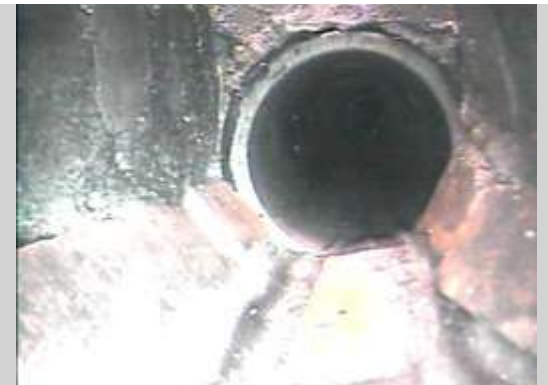
6 in. Circular Gravity Sewer Pipe In @ 7 O'Clock

Infiltration: **Evidence** Pipe Seal Cond: **Unknown**
